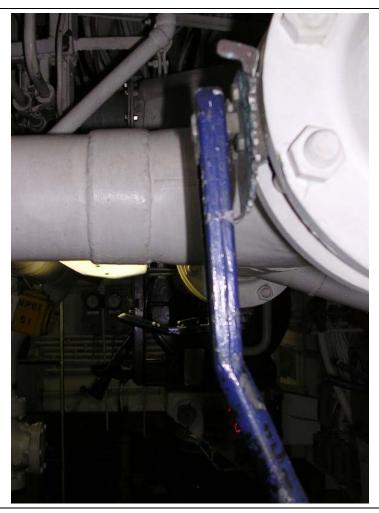
Issue ID #: 246 Pic: 0436x

MMR #1/Machinery Spaces/Valve

Valves should either operate up from centerline or down from centerline, but not up to the centerline.

- Risk of potential incorrect operation and/or delay in operation.
- Risk of striking hazard as the lever pointing down as shown becomes a hazard.

- ASTM F1166 2007, Section 12.4.
- ABS Guidance Notes for the Application of Ergonomics to Marine Systems, Section 7.4.2.

Reorient valve so that the lever will rest in the horizontal position (at the centerline) and operate either moving up or down from horizontal.

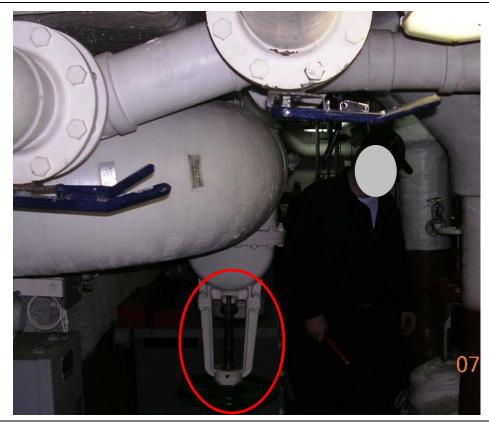
Issue ID #: 247 Pic: 0437x

MMR #1/Machinery Spaces/Valve

- 1. These vertical stem valves should not have the stem pointing down.
- 2. These valves should be located between 30" and 50" above the deck.

- · Increased maintenance requirements.
- Risk of injury to personnel Awkward postures and strain while operating valve due to configuration.

- ASTM F1166 2007, Section 12.3.
- ABS Guidance Notes for the Application of Ergonomics to Marine Systems, Section 7.4.1.

- 1. Reorient valve to stand stem up or turn horizontally.
- 2. Relocate valve to an appropriate height based upon it's orientation in accordance with the standards above as well as the criticality assessment: frequency or use and criticality during emergency situations.

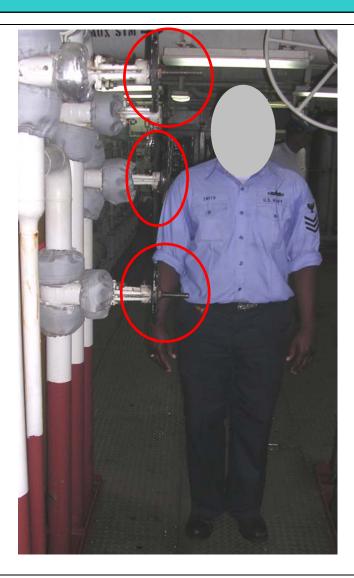
Issue ID #: 248 Pic: 0105x

Auxiliary Machinery Room/Machinery Spaces/Valve

Horizontal stems of valves protrude into this normal walking area at eye and waist level.

Risk of injury to personnel (running in to obstruction).

- ASTM F1166 2007, Section 12.5.
- ABS Guidance Notes for the Application of Ergonomics to Marine Systems, Section 7.2.1.

Relocate valves such that they don't protrude into passageway.

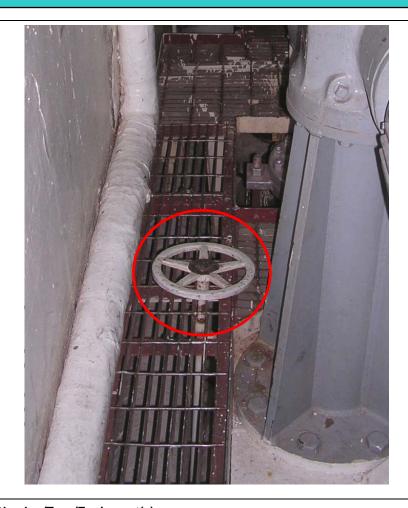
Issue ID #: 249 Pic: 0418x

MMR #1/Machinery Spaces/Valve Handwheel

This valve handwheel is located in the middle of the walkway just inches above grating providing a tripping hazard.

Risk of injury to personnel (trip).

ASTM F1166 - 2007, Section 12.5.2.

Relocate valve handwheel such that it doesn't protrude in to the middle of the passageway, especially just inches off the grating.

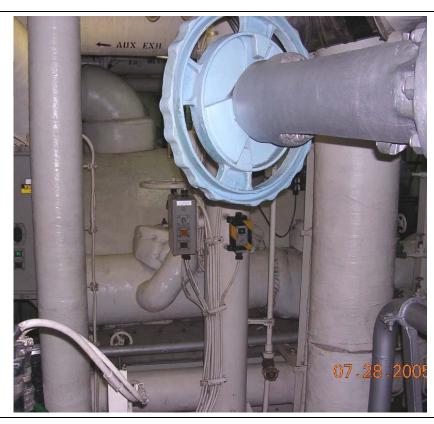
Issue ID #: 250 Pic: 0402x

MMR #1/Machinery Spaces/Valve Handwheel

- 1. Valve handwheel protrudes into passageway.
- 2. The height of the handwheel above deck exceeds the optimal limit for valve operation.

- Risk of injury to personnel (running in to obstruction).
- Risk of failure to operate valve (personnel injury and/or equipment damage).

- ASTM F1166 2007, Section 12.5.
- ABS Guidance Notes for the Application of Ergonomics to Marine Systems, Section 7.2.1.

- 1. Relocate valve handwheel such that it doesn't protrude into passageway.
- 2. Relocate valve handwheel within human performance envelope which is lower than currently positioned, less than 72" off the deck surface.

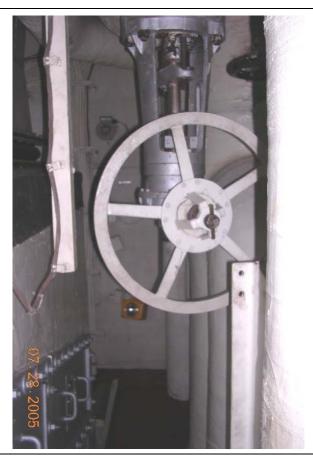
Issue ID #: 251 Pic: 0403x

MMR #1/Machinery Spaces/Valve Handwheel

- 1. Valve handwheel protrudes into passageway.
- 2. Obstructions in front of wheel may impede valve operation.

- Risk of injury to personnel (running in to obstruction).
- Risk failure to operate valve (personnel injury and/or equipment damage).

- ASTM F1166 2007, Section 12.5.
- ABS Guidance Notes for the Application of Ergonomics to Marine Systems, Section 7.2.1.

- 1. Relocate valve handwheel such that it doesn't protrude into passageway.
- 2. Ensure valve handwheel is free of obstruction for operation with two hands (due to size). There should be at least 3" of clearance around the handwheel and room in front for personnel to stand, 24" minimum between the handwheel and the next closest obstruction (wall).

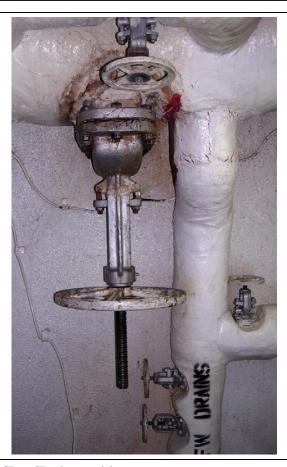
Issue ID #: 252 Pic: 0420x

FWD Main Machinery/Machinery Spaces/Valve

The valve is installed upside down and therefore steam/water leaks, getting into the workings of the valve, significantly increasing the rust and corrosion and ultimately accelerating need for replacement.

Increased maintenance requirements - valve replacement.

- ASTM F1166 2007, Section 12.3.
- ABS Guidance Notes for the Application of Ergonomics to Marine Systems, Section 7.4.1.

Re-orient the valve to eliminate this maintenance requirement to a location that allows the stem to be horizontal or stem pointing up without interfering with physical accessibility and maintaining a safe posture to operate by personnel (handwheel located approximately at waist height).

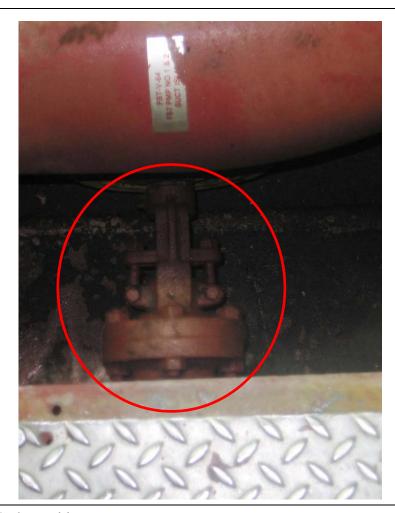
Issue ID #: 253 Pic: 0129x

FWD Main Machinery/Machinery Spaces/Valve

Difficult to access valve beneath grating for operation/maintenance.

- Risk of delay in taking appropriate action (easy access to shutoff valve).
- Risk of injury to personnel (awkward postures, slip/trip exposure to hot surfaces).
- Increased maintenance requirements (poor maintenance performance increased task complexity, task duration).

- ASTM F1166 2007, Section 12.1.
- ABS Guidance Notes for the Application of Ergonomics to Marine Systems, Section 7.2.

Relocate valve to a location more easily accessible by personnel, especially if the valve is required to be operated during emergency situations or with any great frequency which should be determined by a valve criticality assessment.

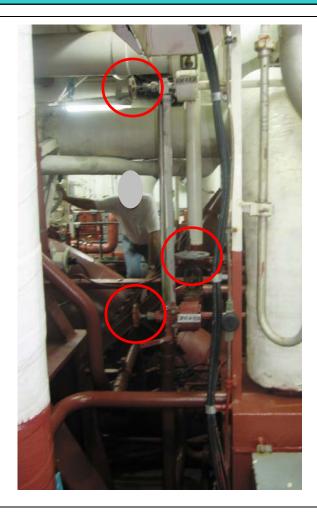
Issue ID #: 254 Pic: 0124x

FWD Main Machinery/Machinery Spaces/Valves

Valve access for operation and/or maintenance will require personnel to crawl from a standing surface on to pipes, structural members and other non-standing surfaces. It is both extremely unsafe and time consuming to rely on this type of accessibility for valves.

- Risk of delay in taking appropriate action (easy access to shutoff valve).
- Risk of injury to personnel (awkward postures, slip/trip exposure to hot surfaces).
- Increased maintenance requirements (poor maintenance performance increased task complexity, task duration).

- ASTM F1166 2007, Section 12.1.
- ABS Guidance Notes for the Application of Ergonomics to Marine Systems, Section 7.2.

Relocate valve to a location more easily accessible by personnel, especially if the valve is required to be operated during emergency situations or with any great frequency which should be determined by a valve criticality assessment.

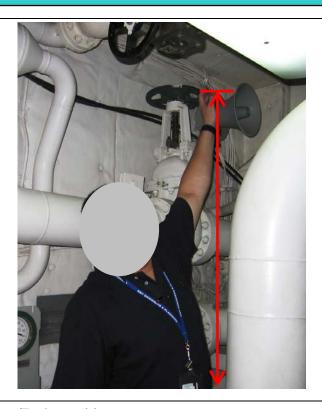
Issue ID #: 255 Pic: 1318x

Auxiliary Machinery Space/Machinery Spaces/Valve

- 1. Location and position of valve requires the operator to reach overhead in order to operate. 95<sup>th</sup> percentile males and smaller would not be able to reach the valve at all without a raised standing surface.
- 2. The fact that the valve is parallel with the deck makes it more difficult to operate even if the user was able to reach the valve.

- Risk of improper operation of valve (leading to injury, equipment damage, or inadequate task performance).
- Risk of delay in taking appropriate action (ease of access to valve) Risk is increased if valve is required for critical operations especially in emergency situations.
- Risk of injury to personnel (fall if standing on a stepladder or temporary platform is required for operation).
- Increased difficulty in task performance (overhead valves parallel with the standing surface are undesirable as
  the posture required creates the least amount of torque as opposed to those mounted perpendicular to the
  deck).

- ASTM F1166 2007, Section 12.3.
- ABS Guidance Notes for the Application of Ergonomics to Marine Systems, Section 7.4.1.

- 1. Relocate the valve to a lower position, preferably between 18" and 51" above the deck.
- Alternately, if the valve cannot be lowered to this degree, orienting the valve stem horizontally will only require lowering it to at least 72" off the deck.

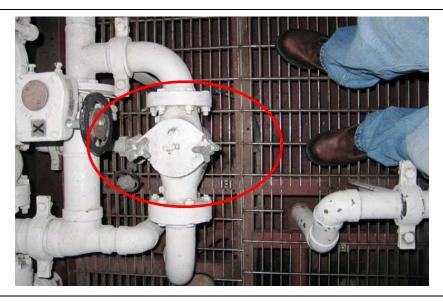
Issue ID #: 256 Pic: 1324x

Auxiliary Machinery Space/Machinery Spaces/Valve Cover Plate

The location and the design of the piping located below an overhead valve encourage personnel to stand on it in order to get closer to the overhead valve for operation.

- Risk of injury to personnel (slip/fall) Using a pipe as a standing surface is extremely dangerous as it provides little room for standing and no traction.
- Increased risk of damage to equipment (damage to the piping due to repeated instances of personnel standing on it).

- ASTM F1166 2007, Section 12.1.1.
- ABS Guidance Notes for the Application of Ergonomics to Marine Systems, Section 7.2.1.

- 1. Change the piping layout so as not to encourage unsafe behavior of personnel by standing on equipment to access valves.
- 2. Add a small platform so as to provide a safe standing surface.

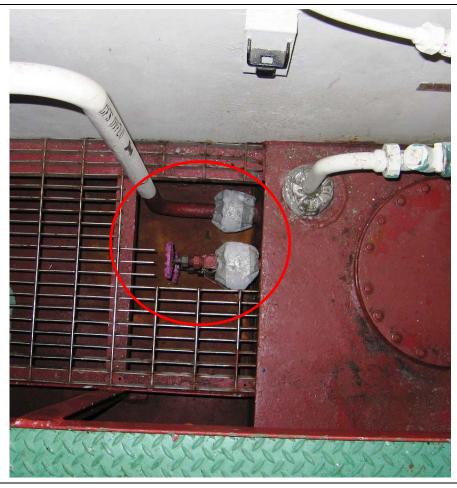
Issue ID #: 257 Pic: 1336x

Auxiliary Machinery Space/Machinery Spaces/Valves

- 1. The small one-handed valve below the grating is difficult to access.
- 2. The second valve, located below the first is even more difficult to access due to the location of the one above.

- Risk of improper operation of valve (leading to injury, equipment damage, or inadequate task performance).
- Risk of delay in taking appropriate action (ease of access to valve) Risk is increased if valve is required for critical operations especially in emergency situations.
- Increased maintenance task complexity (due to access).
- Risk of injury to personnel (hands, awkward posture).

- ASTM F1166 2007, Section 12.1.2 and 12.5.4.
- ABS Guidance Notes for the Application of Ergonomics to Marine Systems, Sections 7.2.1 and 7.5.4.

- 1. Cut back grating in order to access the front of valve handwheels.
- 2. Valves that are required to be used in emergency situations (determined by a valve criticality assessment) should not be located below the grating.
- 3. Provide at least 3" of clearance on all sides of handwheel.
- 4. Offset or configure valves side to side to ease access.

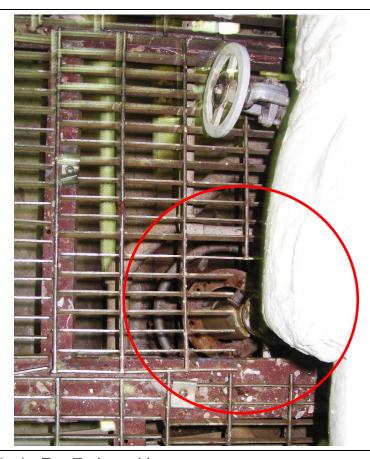
Issue ID #: 258 Pic: 0116x

FWD Main Machinery Space/Machinery Spaces/Valve

Valve located under grating is difficult to access.

- Risk of improper operation of valve (leading to injury, equipment damage, or inadequate task performance).
- Risk of delay in taking appropriate action (ease of access to valve) Risk is increased if valve is required for critical operations especially in emergency situations.
- Increased maintenance task complexity (due to access).
- Risk of injury to personnel (hands, awkward posture).

- ASTM F1166 2007, Section 12.1.2 and 12.5.4.
- ABS Guidance Notes for the Application of Ergonomics to Marine Systems, Sections 7.2.1 and 7.5.4.

- 1. Cut back grating in order to access the front of valve handwheels.
- 2. Valves that are required to be used in emergency situations (determined by a valve criticality assessment) should not be located below the grating.
- 3. Provide at least 3" of clearance on all sides of handwheel.

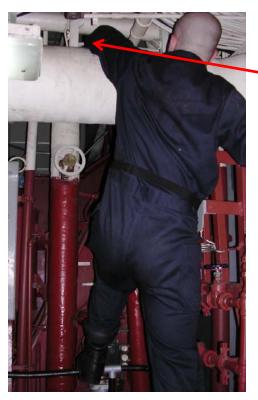
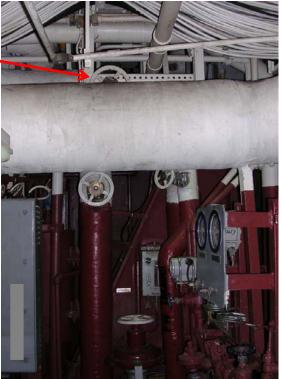
Issue ID #: 259 Pics: 0421x, 0422x

MMR #1/Machinery Spaces/Valve Handwheel

Location and position of valve handwheel requires the operator to step on a structure not intended for standing and reach over a pipe that may be hot.

- Risk of improper operation of valve (leading to injury, equipment damage, or inadequate task performance).
- Risk of delay in taking appropriate action (ease of access to valve) Risk is increased if valve is required for critical operations especially in emergency situations.
- Increased maintenance task complexity (due to access).
- Risk of injury to personnel (fall, awkward posture, exposure to hot surfaces).

- ASTM F1166 2007, Section 12.1.1.
- ABS Guidance Notes for the Application of Ergonomics to Marine Systems, Section 7.2.1.

- 1. Change the piping layout to lower the valve handwheel location so as not to encourage unsafe behavior of personnel by standing on equipment to access valves.
- 2. Add a small platform so as to provide a safe standing surface, if necessary.

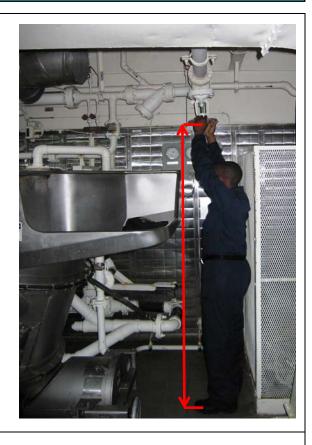
Issue ID #: 260 Pic: 1305x

Pulper Room/Machinery Spaces/Valve

- Location and position of valve (81" above the deck) requires the operator to reach overhead in order to operate. 25<sup>th</sup> percentile males and smaller would not be able to reach the valve at all without a raised standing surface.
- The fact that the valve is parallel with the deck makes it more difficult to operate even if the user was able to reach the valve.

- Risk of improper operation of valve (leading to injury, equipment damage, or inadequate task performance).
- Risk of delay in taking appropriate action (ease of access to valve) Risk is increased if valve is required for critical operations especially in emergency situations.
- Risk of injury to personnel (fall if standing on a stepladder or temporary platform is required for operation)
- Increased difficulty in task performance (overhead valves parallel with the standing surface are undesirable as
  the posture required creates the least amount of torque as opposed to those mounted perpendicular to the
  deck).

- ASTM F1166 2007, Section 12.3.
- ABS Guidance Notes for the Application of Ergonomics to Marine Systems, Section 7.4.1.

- 1. Relocate the valve to a lower position, preferably below 51" above the deck.
- If this is not possible, change to orientation of the handwheel to a horizontal stem and lower to less than 72" off the standing surface.

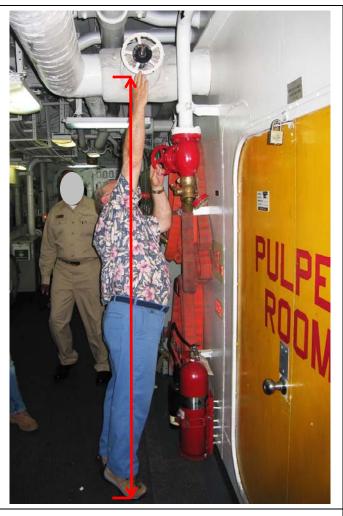
Issue ID #: 261 Pic: 1306x

Passageway/Machinery Spaces/Valve

Location and position of valve (90" above the deck) requires the operator to reach overhead in order to operate. 95<sup>th</sup> percentile males and smaller would not be able to reach the valve at all without a raised standing surface.

- Risk of improper operation of valve (leading to injury, equipment damage, or inadequate task performance).
- Risk of delay in taking appropriate action (ease of access to valve) Risk is increased if valve is required for critical operations especially in emergency situations.
- Risk of injury to personnel (fall if standing on a stepladder or temporary platform is required for operation).

- ASTM F1166 2007, Section 12.3.
- ABS Guidance Notes for the Application of Ergonomics to Marine Systems, Section 7.4.1.

Relocate the valve to a lower position, preferably 72" off the deck or lower. This is a requirement for those valves that are required to be operated frequently or during emergency situations which would be determined by a valve criticality study.

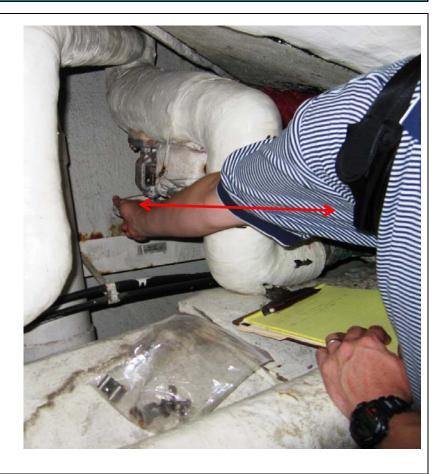
Issue ID #: 262 Pic: 1328x

Auxiliary Machinery Space/Machinery Spaces/Valve

Access to the valve wheel (which requires two hands as it is over 6" in diameter) is located behind piping over 2' laterally from the standing location.

- Risk of improper operation of valve (leading to injury, equipment damage, or inadequate task performance).
- Risk of delay in taking appropriate action (ease of access to valve) Risk is increased if valve is required for critical operations especially in emergency situations.
- Risk of injury to personnel (awkward postures personnel would have to climb in and over piping to operate).
- Increased difficulty in task performance (valve is mounted parallel with the standing surface, the position required to operate it produces less torque than if it were perpendicular with the deck).

- ASTM F1166 2007, Section 12.3.
- ABS Guidance Notes for the Application of Ergonomics to Marine Systems, Section 7.4.1.

- Relocate the valve closer to the standing surface within 19 1/4" in order to meet the reach requirements of a 5<sup>th</sup> percentile female.
- 2. Also rotate the valve so that the wheel is perpendicular with the deck.

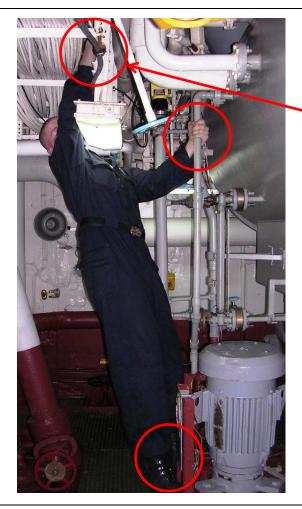
Issue ID #: 263 Pics: 0431x, 0432x

MMR #1/Machinery Spaces/Valve Handwheel

View shows the posture required in order to access a shut off valve. Note: The operation of a valve should never require standing on or grabbing a pipe or structure not meant for standing/grabbing.

- Risk of improper operation of valve (leading to injury, equipment damage, or inadequate task performance).
- Risk of delay in taking appropriate action (ease of access to valve) Risk is increased if valve is required for critical operations especially in emergency situations.
- Risk of injury to personnel (fall if standing on a stepladder or temporary platform is required for operation).

- ASTM F1166 2007, Section 12.3.
- ABS Guidance Notes for the Application of Ergonomics to Marine Systems, Section 7.4.1.

Relocate the valve to a lower position, preferably 72" off the deck or lower. This is a requirement for those valves that are required to be operated frequently or during emergency situations which would be determined by a valve criticality study.

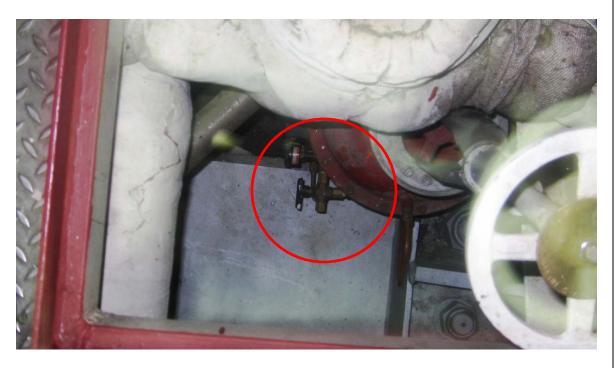
Issue ID #: 264 Pic: 0123x

FWD Main Machinery / Machinery Spaces/Valve

This small, one-handed valve below the deck level is difficult to access due to its adjacent obstructions one would contact while reaching down and depth below the grating.

- Risk of improper operation of valve (leading to injury, equipment damage, or inadequate task performance).
- Risk of delay in taking appropriate action (ease of access to valve) Risk is increased if valve is required for critical operations especially in emergency situations.
- Increased maintenance task complexity (due to access).
- Risk of injury to personnel (hands, awkward posture).

- ASTM F1166 2007, Section 12.1.2 and 12.5.5.
- ABS Guidance Notes for the Application of Ergonomics to Marine Systems, Sections 7.2.1 and 7.5.4.

- 1. Provide at least 3" of clearance on all sides of the valve.
- 2. Mount the valve handwheel no more than 24" below the standing surface.
- 3. Valves that are required to be used in emergency situations (determined by a valve criticality assessment) should not be located below the grating.

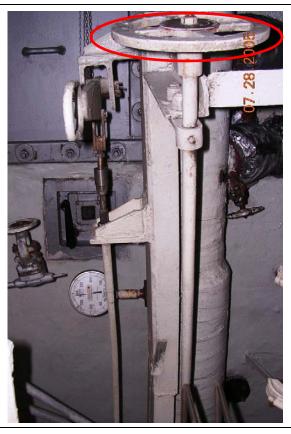
Issue ID #: 265 Pic: 0411x

MMR #1/Machinery Spaces/Valve Handwheel

- 1. The vertical stem handwheel is above the level for normal operation by personnel from the top.
- 2. The gauge display is oriented more than 90 degrees from upright which makes it difficult to read accurately.

- Risk of improper operation of valve (leading to injury, equipment damage, or inadequate task performance).
- Risk of delay in taking appropriate action (ease of access to valve) Risk is increased if valve is required for critical operations especially in emergency situations.
- Increased maintenance task complexity (due to access).
- Risk of injury to personnel (hands, awkward posture).

ASTM F1166 – 2007, Sections 6.2.4 and 10.3.2.

- Relocate valve handwheel to an appropriate height for operation from the top, which should be below 51" off the standing surface.
- 2. Rotate the gauge 90 degrees in order to be read upright.
